PROJECT INFORMATION SHEET

Project Title	ND/GAS1331 Sankey Brook Bank Repairs
Client	National Grid.
Start Date	October 2011
Finish Date	November 2011

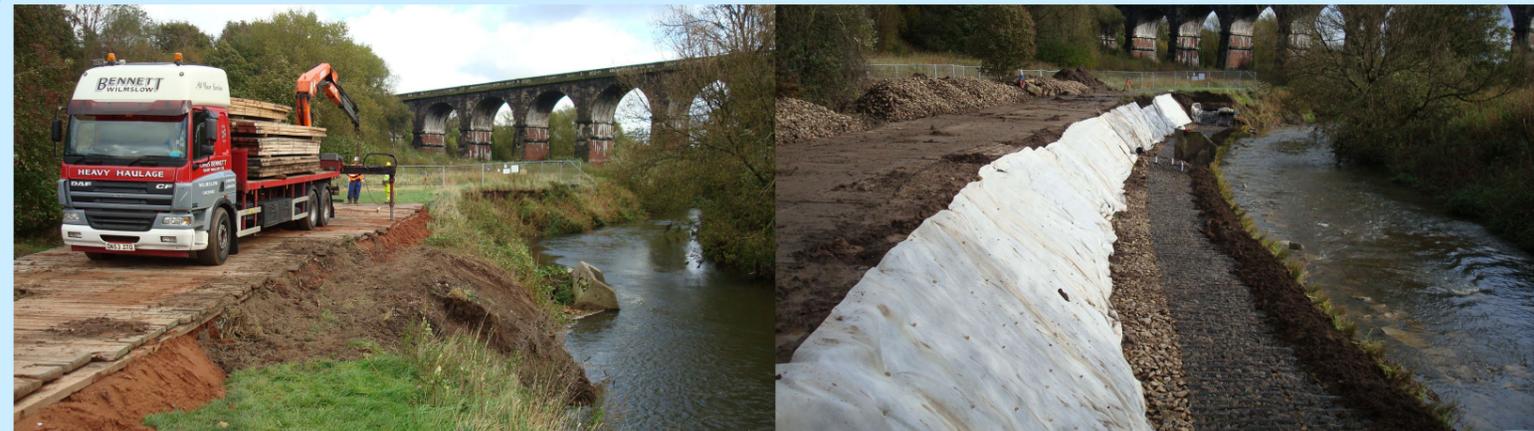
In order to maintain at least 1.0m of cover to the gas pipeline alongside the watercourse, a temporary track of sand and timber mats was constructed for site vehicles and plant to run along.

Photo 1: Construction of temporary access track using sand and timber mats.

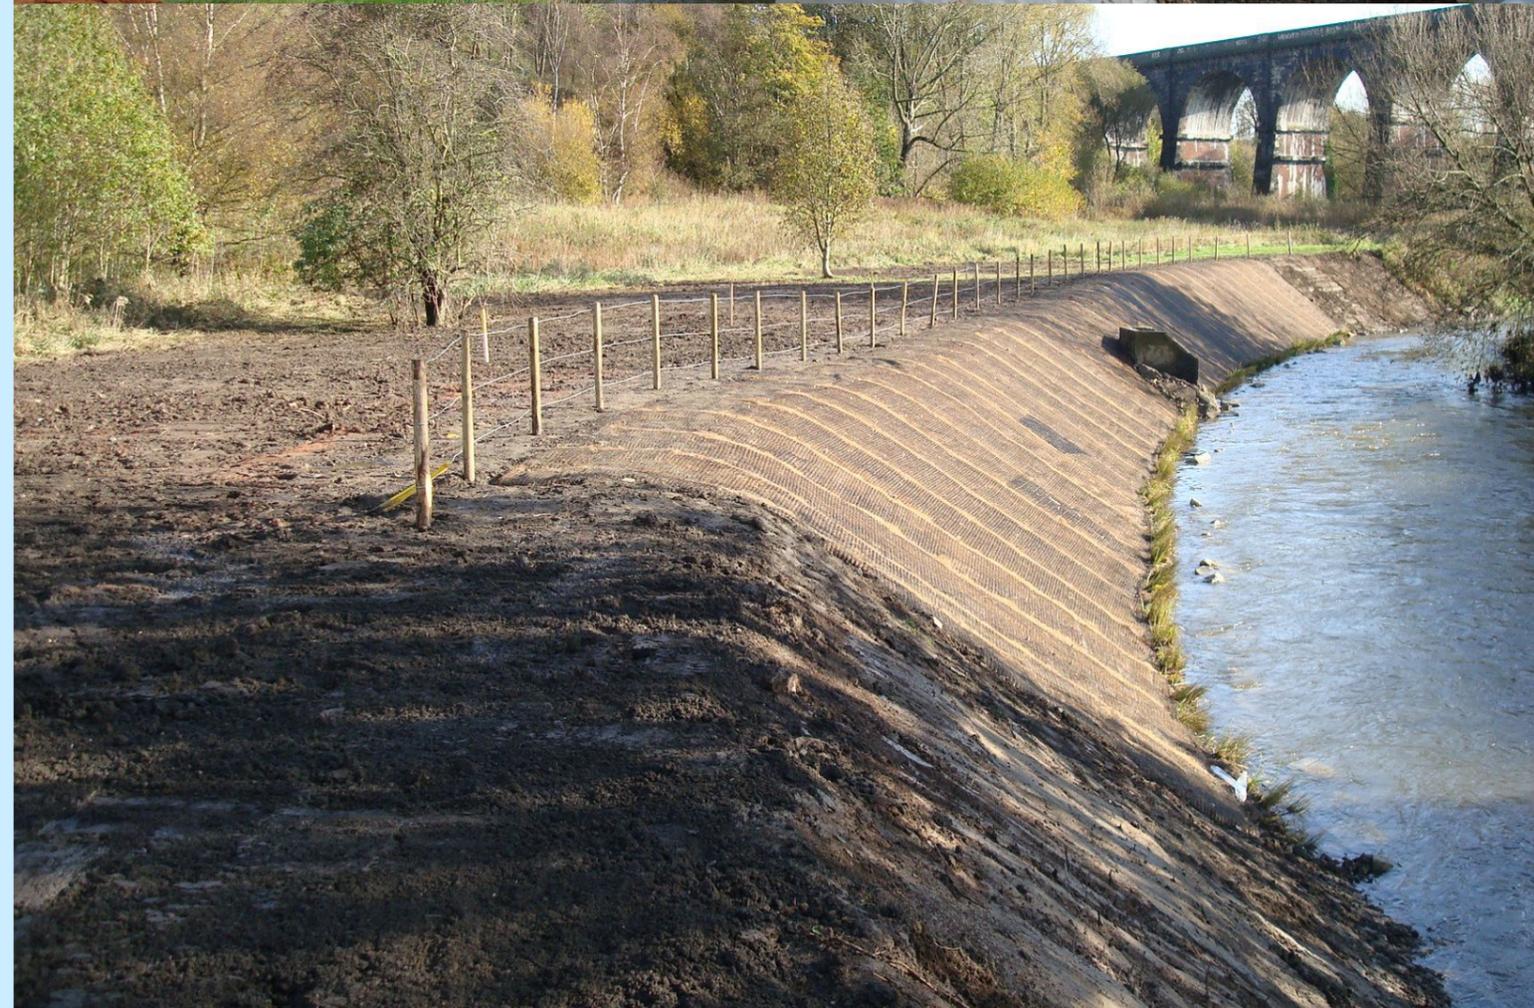
The design comprised excavation of the bank and toe, placement of a rip-rap foundation with a 150mm layer of smaller grit stone on top and a row of pre-seeded coir and rock rolls in front. The bank was then built-up with stone in 400mm layers with Geogrid reinforcement between and topped with soil and seeded Salix C350 nag matting.

Photo 3: Pre-seeded coir and rock-rolls along toe of bank and build-up of batter using stone with Terram behind.

Photo 4: Continued build-up of batter using stone in 400mm layers with Geogrid reinforcement between.
